System Performance and Detectable Faults of a 10-Year Old 1.1 kWp GCPV System in Malaysia

Abstract - This paper presents the findings of a study conducted to evaluate the performance and to identify faults of a 10-year old 1.1kW grid-connected photovoltaic (GCPV) system installed at Green Energy Research Center (GERC), Universiti Teknologi MARA (UiTM), Shah Alam. The system performance was evaluated by comparing the real operating field data with the data declared by the manufacturer. Eight performance indicators were used, which are: reference yield, array yield, final yield, capture losses, system losses, performance ratio, PV array efficiency and total efficiency. The fault detection has used three techniques - which were visual inspection as outlined in the International Energy Agency (IEA) document, thermal imager technique and the I-V curve characteristics. The finding for the system performance evaluation gives a 13.2% difference between the real operating field data and the declared manufacturer data. Among the faults detected from the visual inspection are browning and cracks of PV modules.

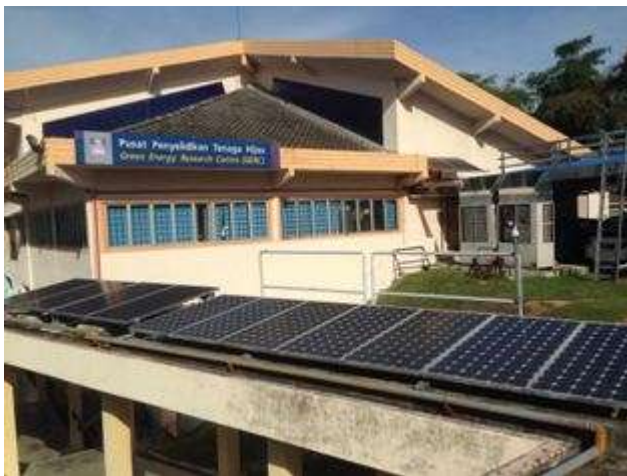
Fig. 1 PV systems installed

Figure 1 shows the system installed that was installed in 2004, and the details of the PV array are shown in Table 2.

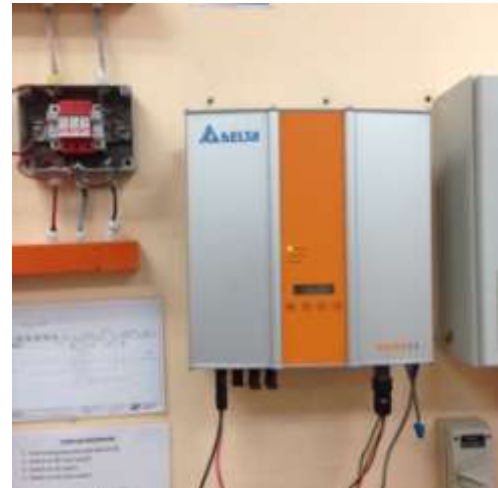
Fig. 2 Inverter

A single grid-connected inverter model Solivia 3.3TR is connected to the utility grids show in Fig. 1. The characteristics of the inverter are as follows (Table 3):

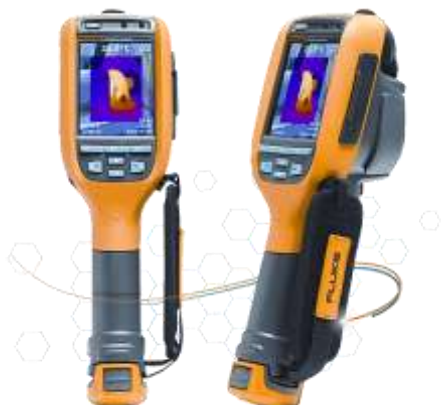
Figure 3 FLUKE Ti125 IR camera the thermal imager equipment for thermographic techniques [13]

Infrared photographs of the solar module were taken using a FLUKE Ti125 IR camera (refer Figure 3 and Table 5). The measurement were taken while the panel is under load and exposed to ambient lighting on a clear day. The infrared images allow the identification of possible hot spots and cracks within the module. This inspection allows the detection of defects which are not visible with a naked eye. These include cracked or broken cells, hot spots in the cells or their connections and soldering, non active cells or regions which do not contribute to photogeneration and failures in bypass diodes [12].
