System Performance and Detectable Faults of a 10-Year Old 1.1 kWp GCPV System in Malaysia

Abstract - This paper presents the findings of a study conducted to evaluate the performance and to identify faults of a 10-year old 1.1kW grid-connected photovoltaic (GCPV) system installed at Green Energy Research Center (GERC), Universiti Teknologi MARA (UiTM), Shah Alam. The system performance was evaluated by comparing the real operating field data with the data declared by the manufacturer. Eight performance indicators were used, which are: reference yield, array yield, final yield, capture losses, system losses, performance ratio, PV array efficiency and total efficiency. The fault detection has used three techniques - which were visual inspection as outlined in the International Energy Agency (IEA) document, thermal imager technique and the I-V curve characteristics. The finding for the system performance evaluation gives a 13.2% difference between the real operating field data and the declared manufacturer data. Among the faults detected from the visual inspection are browning and cracks of PV modules.

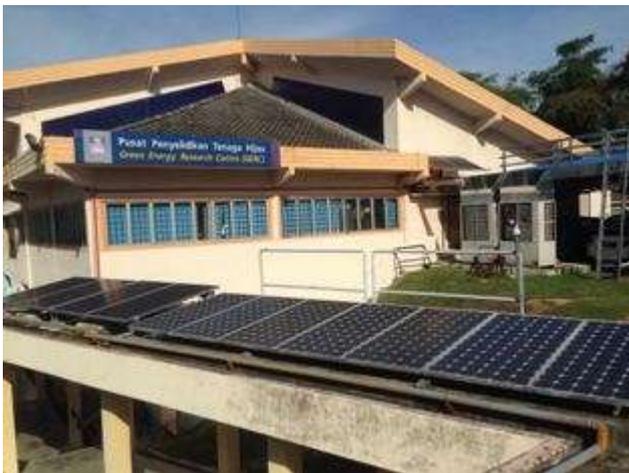
Fig. 1 PV systems installed

Figure 1 shows the system installed that was installed in 2004, and the details of the PV array are shown in Table 2.

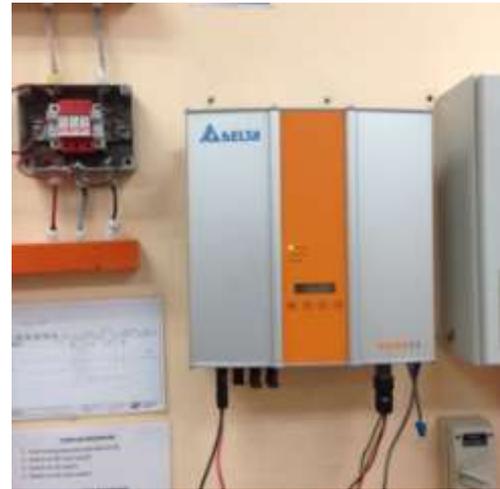
Fig. 2 Inverter

A single grid-connected inverter model Solivia 3.3TR is connected to the utility grids show in Fig. 1. The characteristics of the inverter are as follows (Table 3):

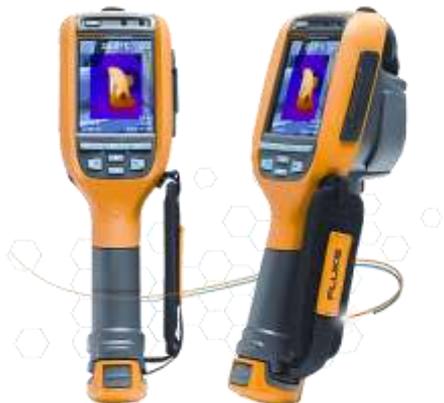
Figure 3 FLUKE Ti125 IR camera the thermal imager equipment for thermographic techniques [13]

Infrared photographs of the solar module were taken using a FLUKE Ti125 IR camera (refer Figure 3 and Table 5). The measurement were taken while the panel is under load and exposed to ambient lighting on a clear day. The infrared images allow the identification of possible hot spots and cracks within the module. This inspection allows the detection of defects which are not visible with a naked eye. These include cracked or broken cells, hot spots in the cells or their connections and soldering, non active cells or regions which do not contribute to photogeneration and failures in bypass diodes [12].

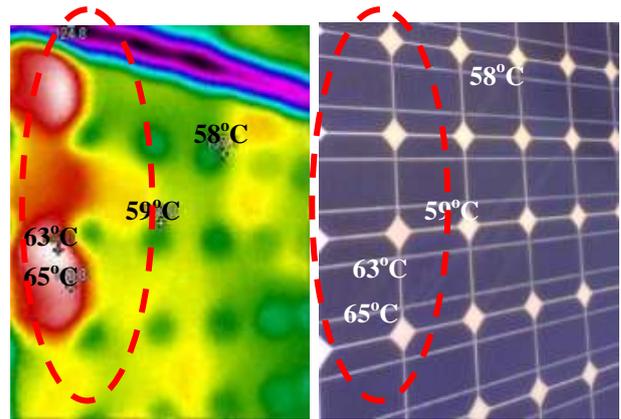
The module temperature of PV panel photographs as taken by FLUKE Ti125 thermal camera have shown there are several spots on the PV modules have higher

temperature compared to the overall surface. Figure 4 to 6 show the details.

Figure 4 PV module with discoloration defect shows slightly higher temperature on certain spots

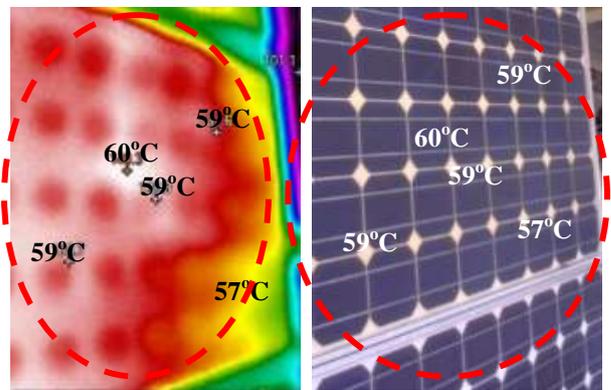
Figure 5 PV module with discoloration defect shows mostly higher temperature on certain spots

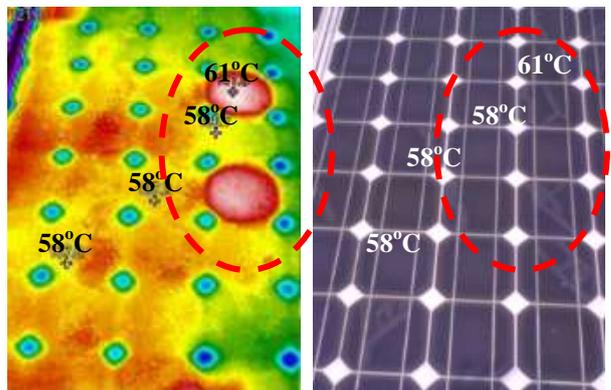
Figure 6 PV module with snails track show slightly higher temperature on certain spots

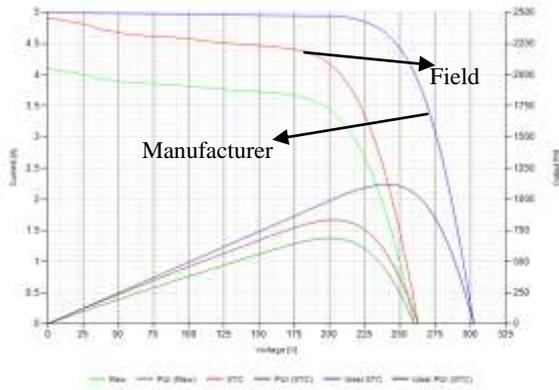
Figure 7 IV curve graphs from TRI-KA measurement

Table 7 shows the value extracted from TRI-KA the mobile IV curve tracer. The data have shown that the errors contribution mostly from V_{mpp} and P_{mpp} . The lost value of V_{mpp} is almost 39.3 V which is 19.5%. The value shows that the lost was almost likely consumed a single module where a single module contributes 34.4 V V_{mpp} . In contrast, the P_{mpp} loss value was 285 W most likely 2 modules had faults. To conclude, the system might have lost several modules due to fault or each modules have contributes faults as the total of power lost was high. The field factor (FF) also reaffirm the lost about 13.85% compared to the manufacturer value caused by the faulty modules.

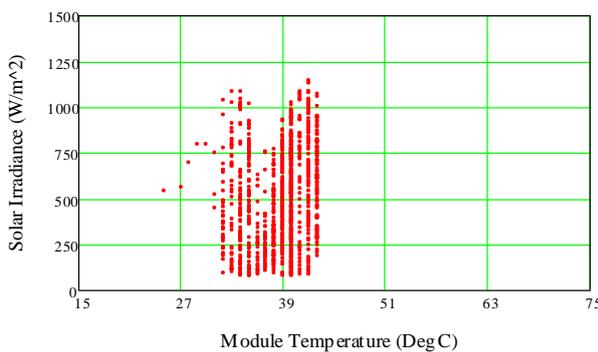
Figure 8 Module temperature using temperature sensor data logger

It can be seen that the module temperature detected from thermal imager were slightly higher compared to the module temperature detected using temperature sensor. Figure 8 and 9 stated that the value using thermal imager were around 37°C to 60°C compared to the values taken from temperature sensor range only within 27°C to 42°C. The difference between these values are each PV modules thermal image were taken using the thermal camera, hence the average values of the temperature was the contribution of every single PV modules on the systems compared to values from temperature sensor. It is because only one sensor placed on the PV system as represented for the whole systems.

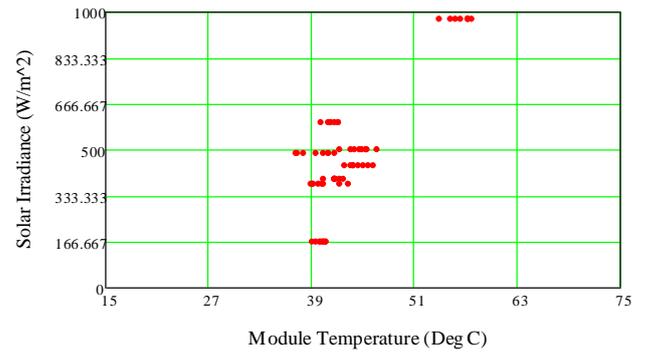
Figure 9 Module temperature using thermal imager

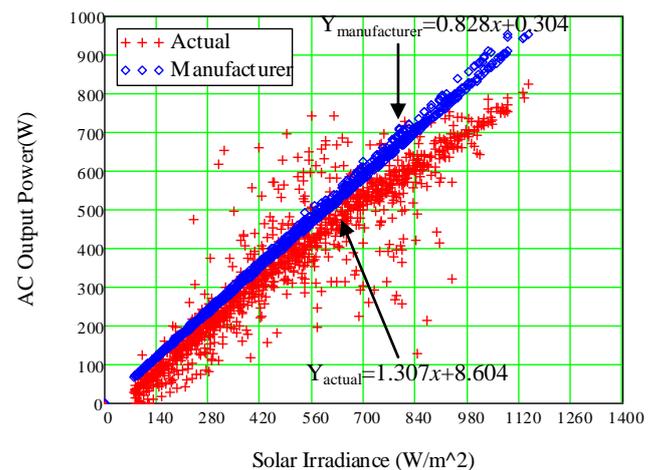
1) Performance of PV array: The performance of PV array is illustrated in Figure 10. In Figure 10, the AC output power generated by the PV modules is linearly dependent on the in-plane irradiance, except for lower irradiance values. At irradiance values lower than 80 W/m², the output power was found to be approximately zero. As the irradiance increases, the AC power generated by PV array correspondingly increases.

Figure 10 The relationship between the output power of PV array and the in-plane irradiance

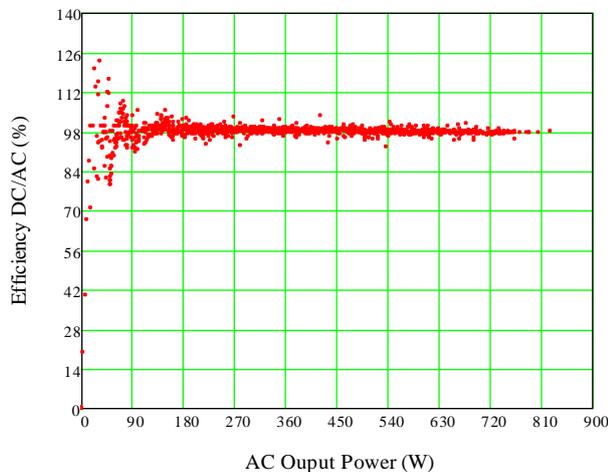
2) *Performance of inverter:* The inverter performance can be characterized from its operating efficiency behaviour [17]. In Figure 11, the value of inverter efficiency and the value of nominal AC output power were used for the plot. The actual inverter efficiency was found at 98%. Therefore, the results showed that the inverter was operating near to the rated maximum efficiency during the monitoring period. The efficiency decreased when the AC power generated was below than 10% of the nominal power. In contrast, the maximum efficiency was achieved when the inverter generated AC power more than 10% of the rated nominal output power. Nevertheless, the inverter is operating within its rated values.

Figure 11 The relationship between the inverter efficiency and AC output power
